# **INDOOR AIR QUALITY ASSESSMENT**

**Middle School East  
45 Main Street  
Milford, MA 01757**

Prepared by:  
Massachusetts Department of Public Health  
Center for Environmental Health  
Bureau of Environmental Health Assessment  
Emergency Response/Indoor Air Quality Program  
September 2004

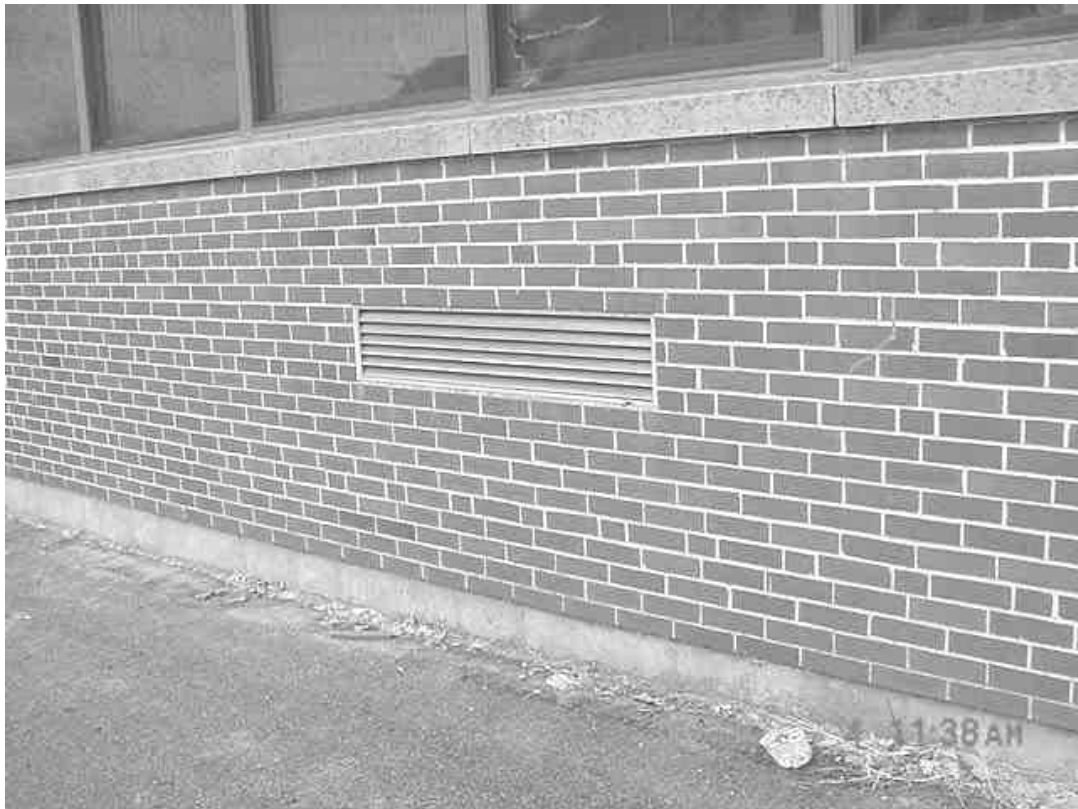
**Picture 1**

It can be seen from Table 1 that carbon dioxide levels were above 800 parts per million (ppm) in 12 of 28 areas, indicating inadequate ventilation in some areas surveyed. Fresh air in classrooms of both the original wing and 1960 addition is mechanically supplied by a unit ventilator (univent) system ([Figure 1](#)). Univents draw air from outdoors through a fresh air intake located on the exterior walls of the building (Picture 1) and return air through an air intake located at the base of each unit. Fresh and return air are mixed, filtered, heated and provided to classrooms through an air diffuser located in the top of the unit. Univents were found deactivated in a number of classrooms. Obstructions to airflow, such as items on top of univents, and tables and desks in front of univent returns were also seen in a number of classrooms. To function as designed, univents must be activated and allowed to operate. Importantly, univent air diffusers and univent returns must remain free of obstructions.

**Univent Fresh Air Intake**

1. Examine each univent for function. Survey classrooms for univent function to ascertain if an adequate air supply exists for each room. Consider consulting a heating, ventilation and air conditioning (HVAC) engineer concerning the calibration of univent fresh air control dampers.

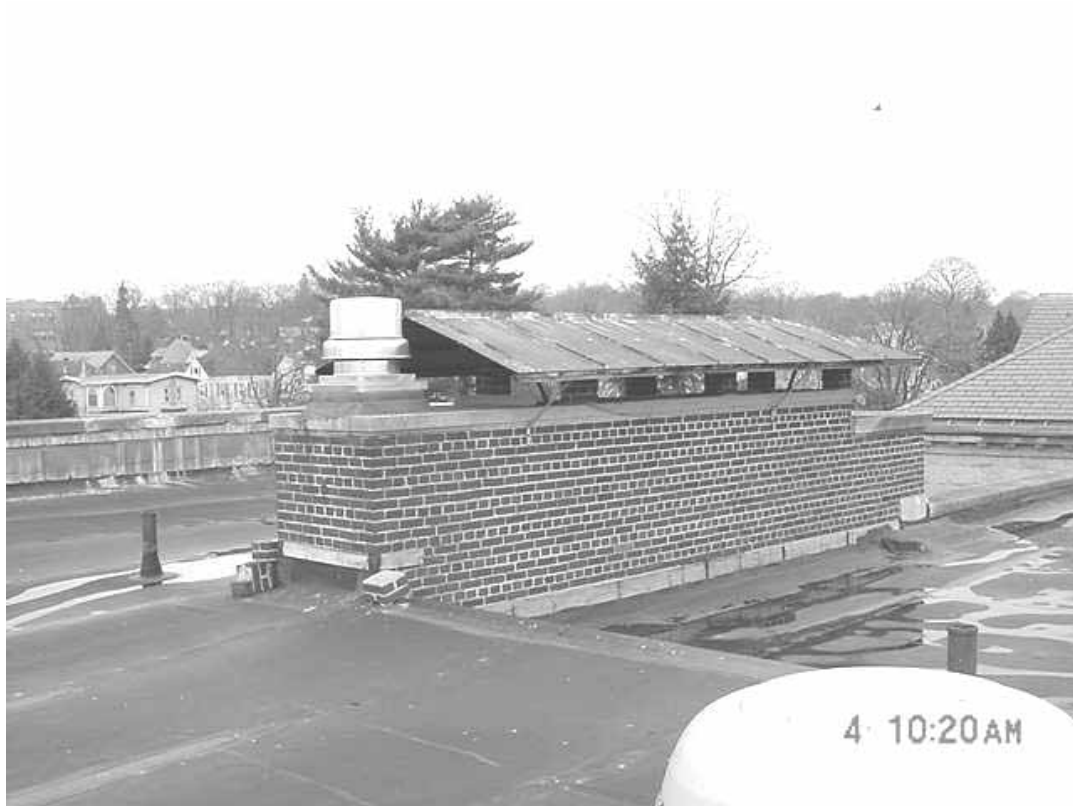
**Picture 2**

The original building has no means of mechanical exhaust ventilation, but relies on a natural gravity system (Picture 2). Mechanical exhaust ventilation in the 1960 wing is provided by rooftop motors and ducted to classroom vents (Pictures 3 and 4). A number of these vents were found obstructed by various items in several classrooms (Picture 4). Without sufficient supply and exhaust ventilation, environmental pollutants can build up, leading to indoor air quality complaints. As with univents, exhaust vents must remain free of obstructions.

**Natural Gravity Feed Vents on Roof of Original Building**

3. Inspect exhaust motors and belts for proper function. Repair and replace as necessary.
4. Consider installing motorized fans on existing (gravity feed) ductwork to provide mechanical exhaust ventilation. This is of particular importance in room 25. Consideration of a local exhaust system dedicated to collecting equipment dust should also be given to the technical education classroom. If not feasible, consider discontinuing use of wood cutting machinery in classroom 25.

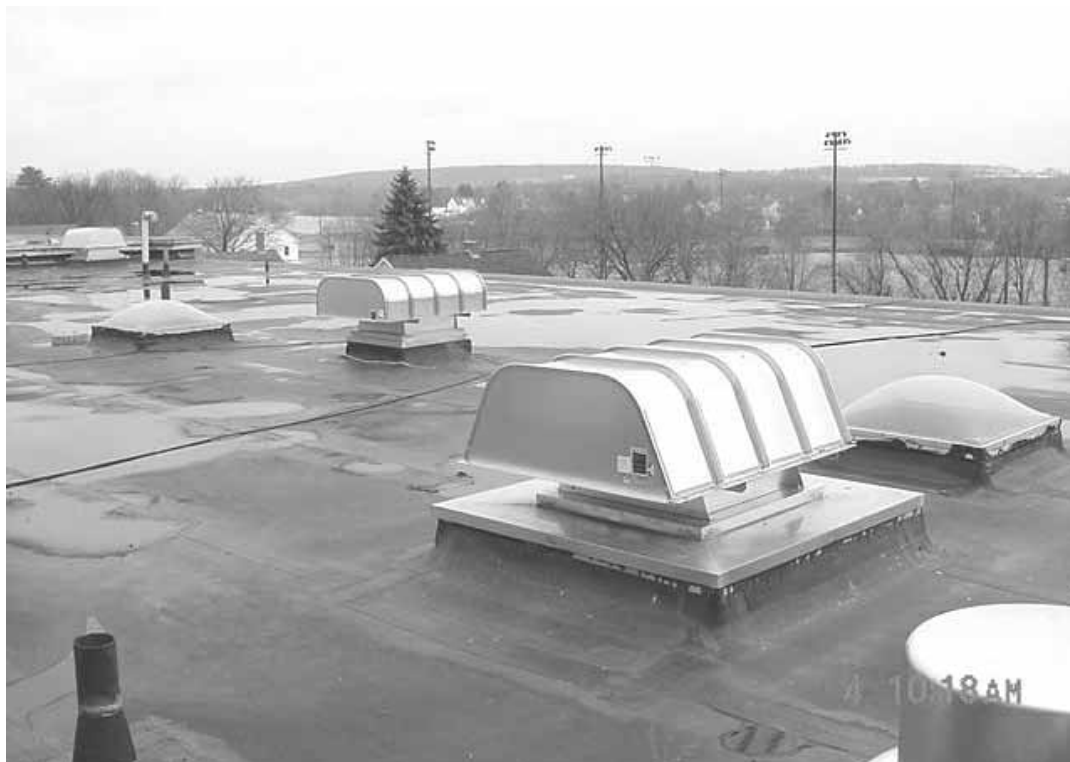
**Picture 3**

**Mechanical Exhaust Fans on Roof of the 1960 Wing**

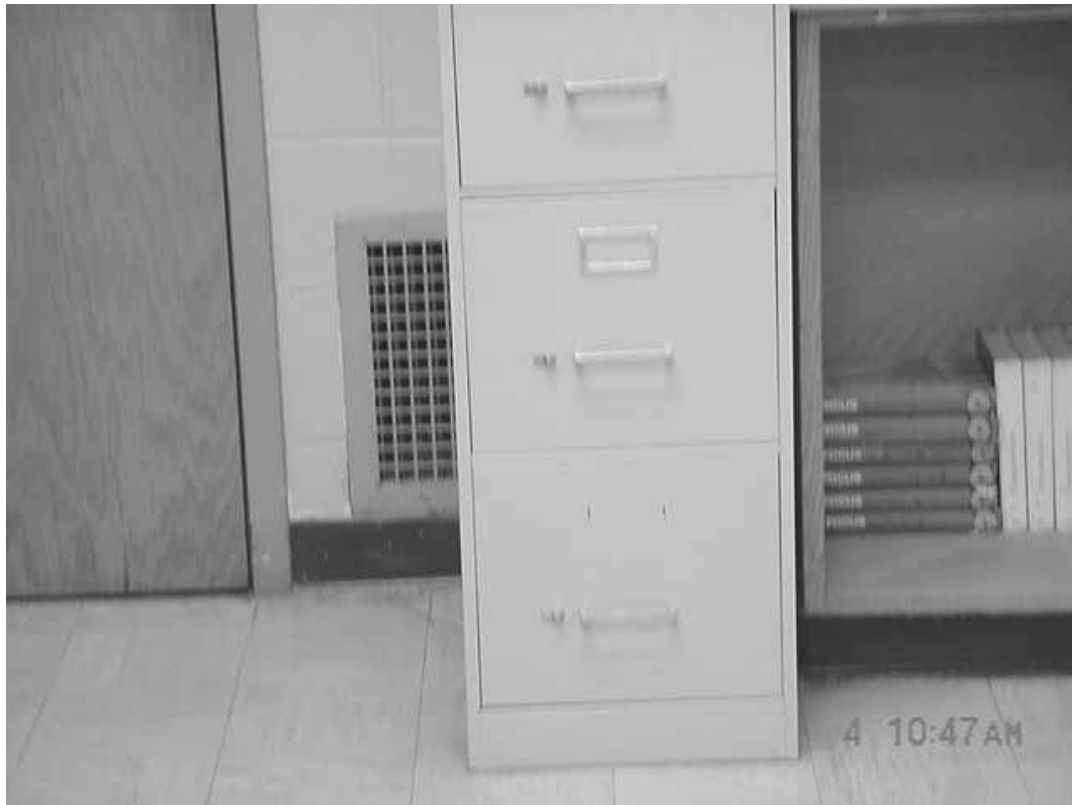
**Picture 4**

**Classroom Exhaust Vent Obstructed by File Cabinet**

5. Remove all blockages from univents and exhaust vents to ensure adequate airflow.
6. Install a passive vent in the door to computer room 71-B to provide air exchange.

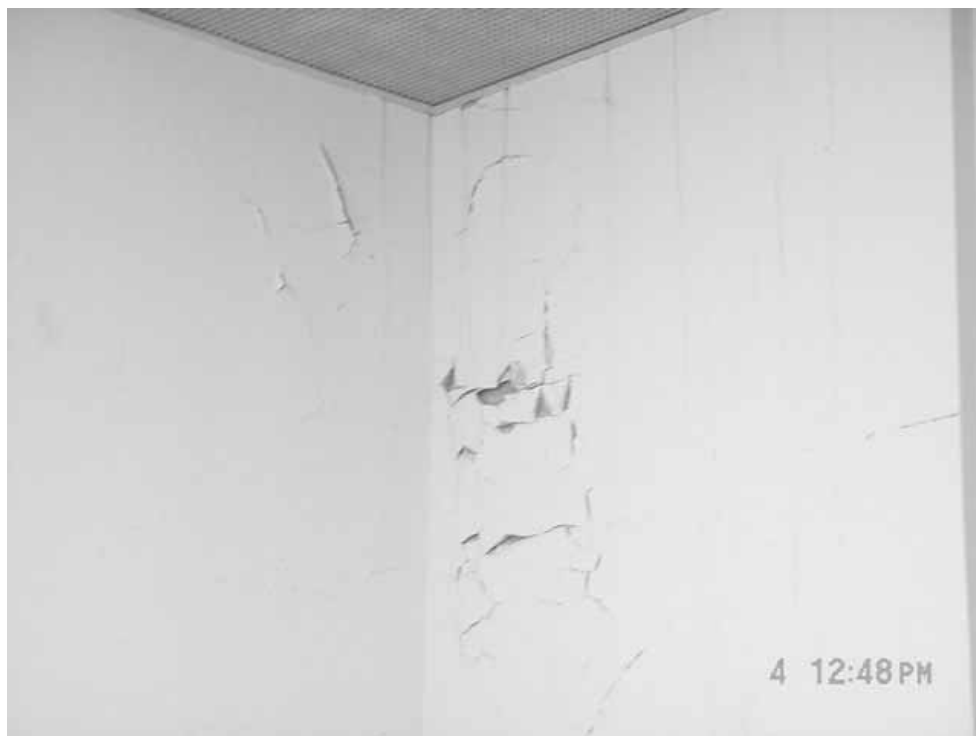
**Picture 5**

Elevated moisture content was detected in wall plaster in the library (Picture 5). A roof leak in the corner of the library was reportedly repaired recently. At the time of the assessment,

**Water Damaged Wall Plaster in Library**

BEHA staff recommended drying this area with fans and heat. The US Environmental Protection Agency (US EPA) and the American Conference of Governmental Industrial Hygienists (ACGIH) recommends that porous materials be dried with fans and heating within 24 to 48 hours of becoming wet (US EPA, 2001; ACGIH, 1989). If porous materials are not dried within this time frame, mold growth may occur. Water-damaged porous materials cannot be adequately cleaned to remove mold growth. The application of a mildewcide to moldy porous materials is not recommended.

10. Continue with plans for roof replacement. Ensure leaks are repaired and replace water damaged ceiling tiles and wall plaster. Examine the area above and around these areas for mold growth. Disinfect areas of water leaks with an appropriate antimicrobial.

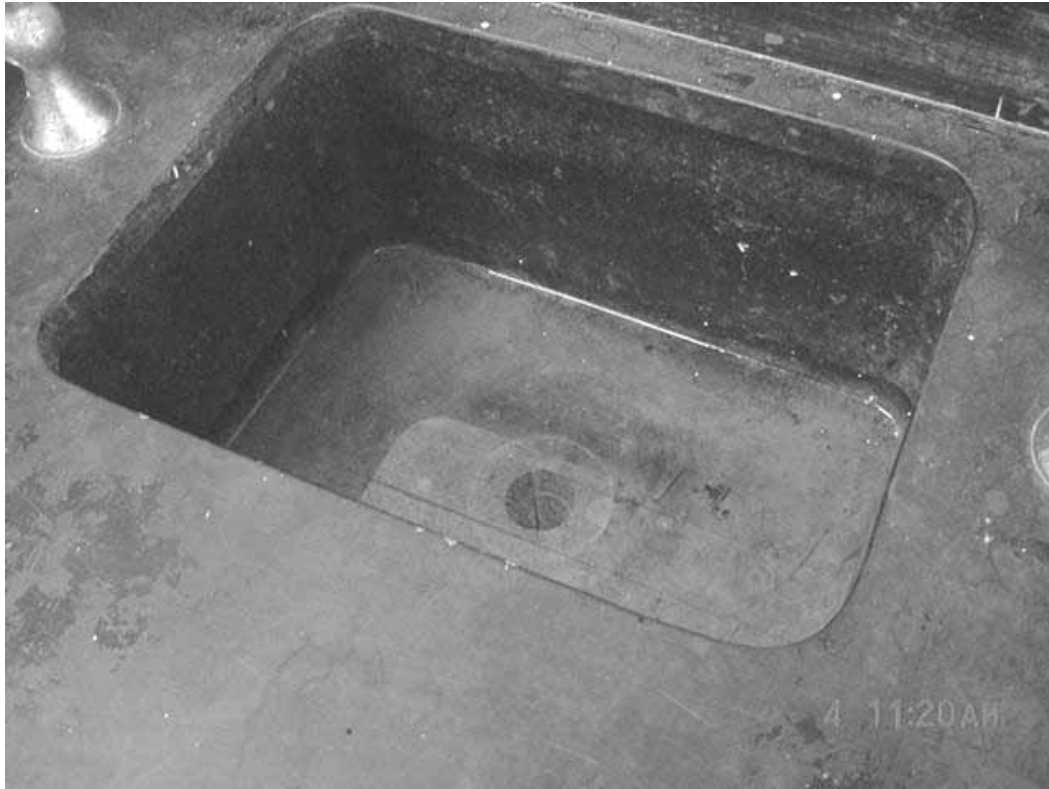
**Picture 6**

Clogged sinks with standing water were noted in science classroom 202 (Picture 6). If sinks do not drain properly, standing water can become stagnant and provide a source of mold growth and odors.

**Clogged Sink With Standing Water in Science Room**

11. Unclog drains in science area. If necessary, contact a licensed plumbing contractor to make repairs.
12. Consult “Mold Remediation in Schools and Commercial Buildings” published by the US EPA (2001) for further information on mold. Copies of this document can be downloaded from the US EPA website at: [http://www.epa.gov/iaq/molds/mold\\_remediation.html](http://www.epa.gov/iaq/molds/mold_remediation.html).

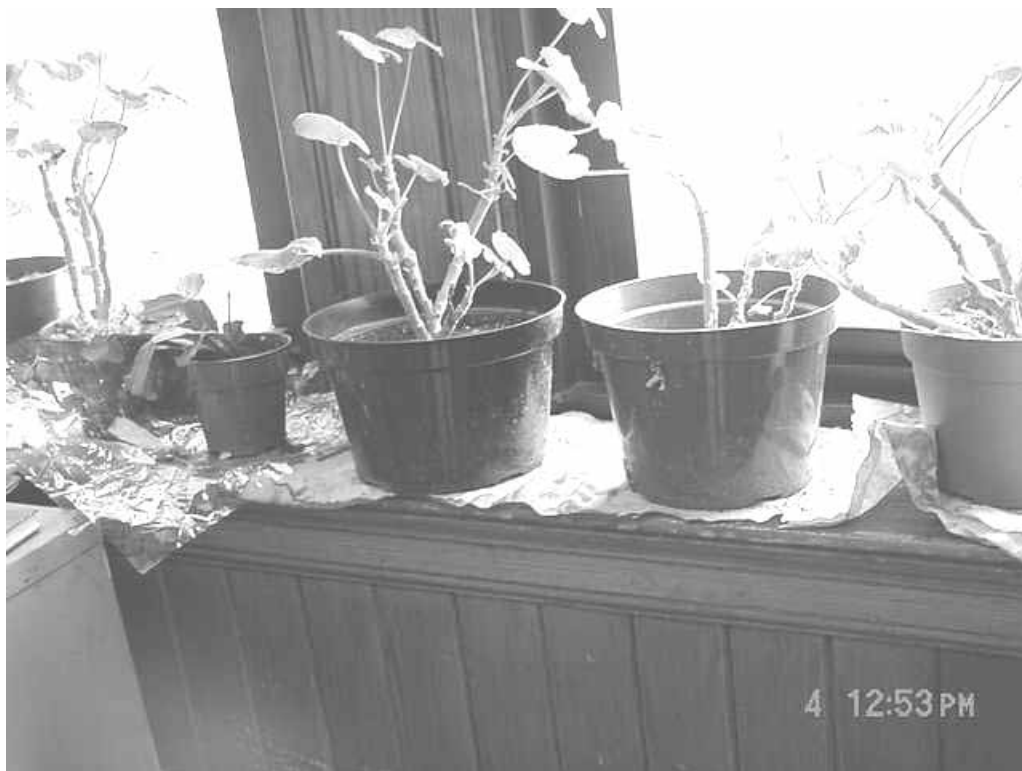
**Picture 7**

Plants were observed in several classrooms. Plants, soil and drip pans can serve as sources of mold growth. Plants should be properly maintained, over-watering of plants should be avoided and drip pans should be inspected periodically for mold growth. Plants in one classroom were located on top of paper towels (Picture 7). Paper towels are a porous material that can provide a medium for mold growth, especially if wetted repeatedly. Plants should also be located away from ventilation sources to prevent aerosolization of dirt, pollen or mold.

**Plants on top of Paper Towels**

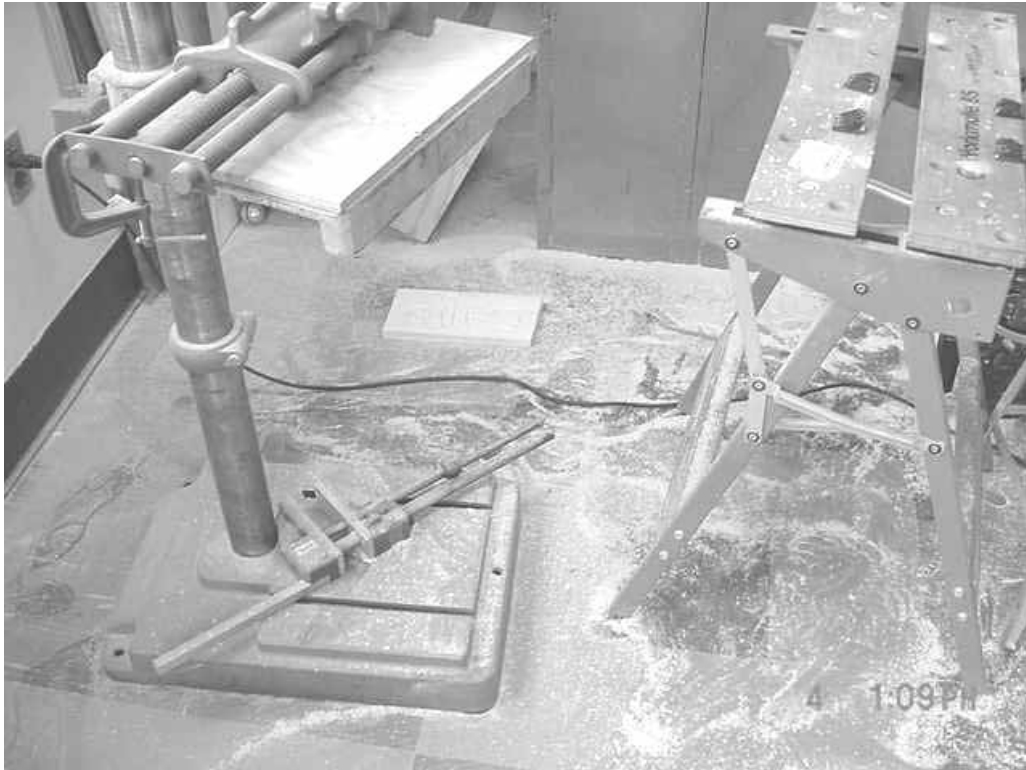
**Picture 8**

Of particular note is the technical education classroom, room 25, which had an elevated PM<sub>2.5</sub> reading of 827 µg/m<sup>3</sup>. Wood dust and debris were observed on flat surfaces throughout the room (Picture 8). This second floor classroom contained a number of wood cutting machines that were operating during the assessment. This classroom did not have general exhaust ventilation to remove naturally occurring pollutants. In addition, the room lacked a local exhaust system dedicated to collecting dust from equipment.

**Unvented Wood Cutting Machines and Debris in Classroom 25**

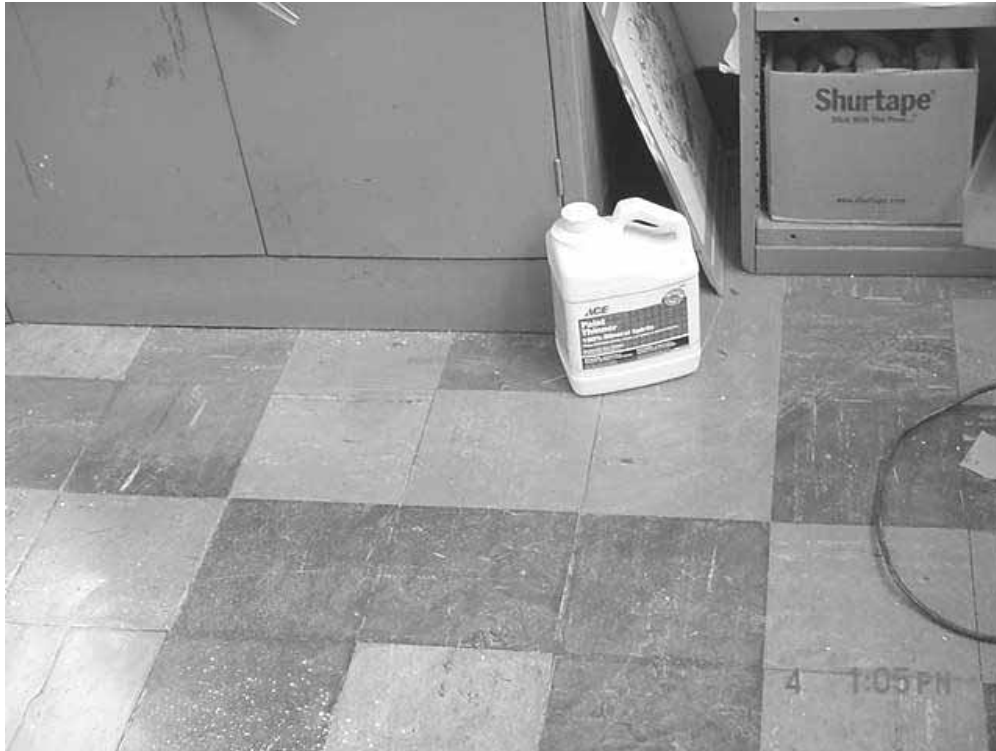
**Picture 9**

Please note, that the TVOC air measurements are only reflective of the indoor air concentrations present at the time of sampling. Indoor air concentrations can be greatly impacted by the use of TVOC containing products. While no TVOC levels measured exceeded background levels, materials containing VOCs were present in the school. A container of paint thinner was observed on the floor next to an empty flammable storage locker (Picture 9). In

addition to containing potentially irritating VOCs, paint thinner is a highly flammable material. Several classrooms contained dry erase boards and dry erase board markers. Materials such as dry erase markers and dry erase board cleaners may contain VOCs, such as methyl isobutyl ketone, n-butyl acetate and butyl-cellusolve (Sanford, 1999), which can be irritating to the eyes, nose and throat.

**Container of Paint Thinner on Floor Next to Flammable Cabinet**

16. Ensure flammable products are stored in the proper cabinets.
17. Consider discontinuing the use of tennis balls on chairs to prevent latex dust generation.

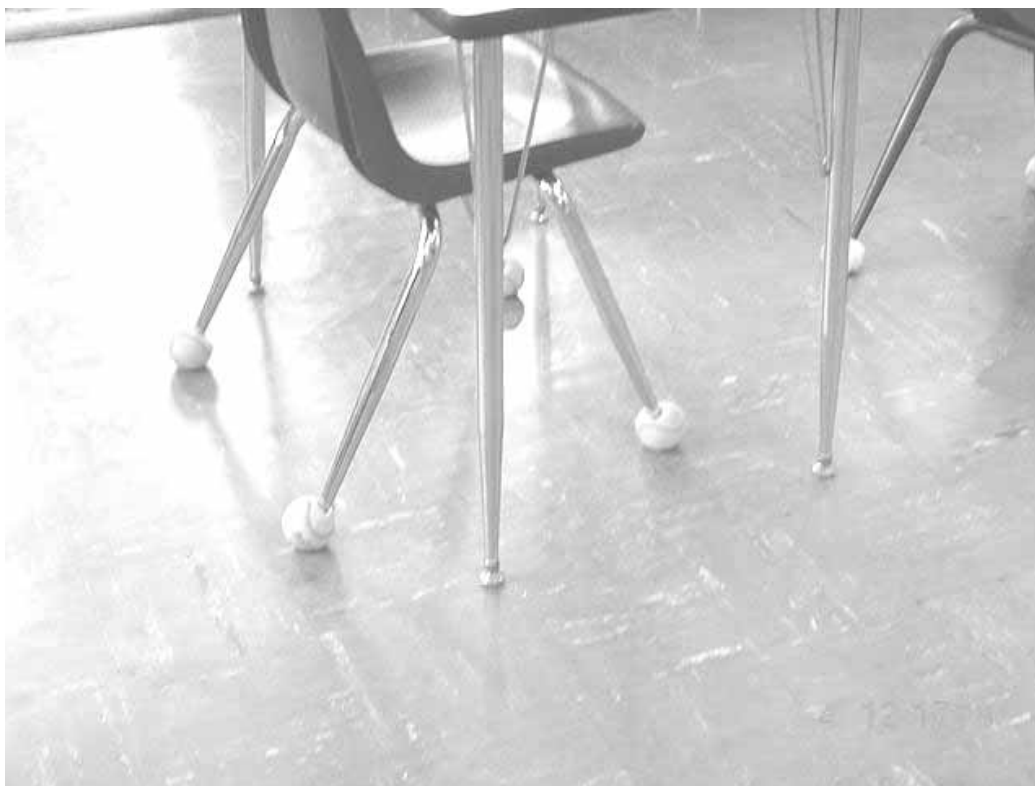
**Picture 10**

In an effort to reduce noise from sliding chairs, tennis balls had been spliced open and placed on chair legs (Picture 10). Tennis balls are made of a number of materials that are a source of respiratory irritants. Constant wearing of tennis balls can produce fibers and off-gas VOCs. Tennis balls are made with a natural rubber latex bladder, which becomes abraded when used as a chair leg pad. Use of tennis balls in this manner may introduce latex dust into the school environment. Some individuals are highly allergic to latex (e.g., spina bifida patients) (SBAA, 2001). It is recommended that the use of materials containing latex be limited in buildings to reduce the likelihood of symptoms in sensitive individuals (NIOSH, 1997). A question and answer sheet concerning latex allergy is attached as [Appendix B](#) (NIOSH, 1998).

**Tennis Balls on Chair Legs in Classroom**

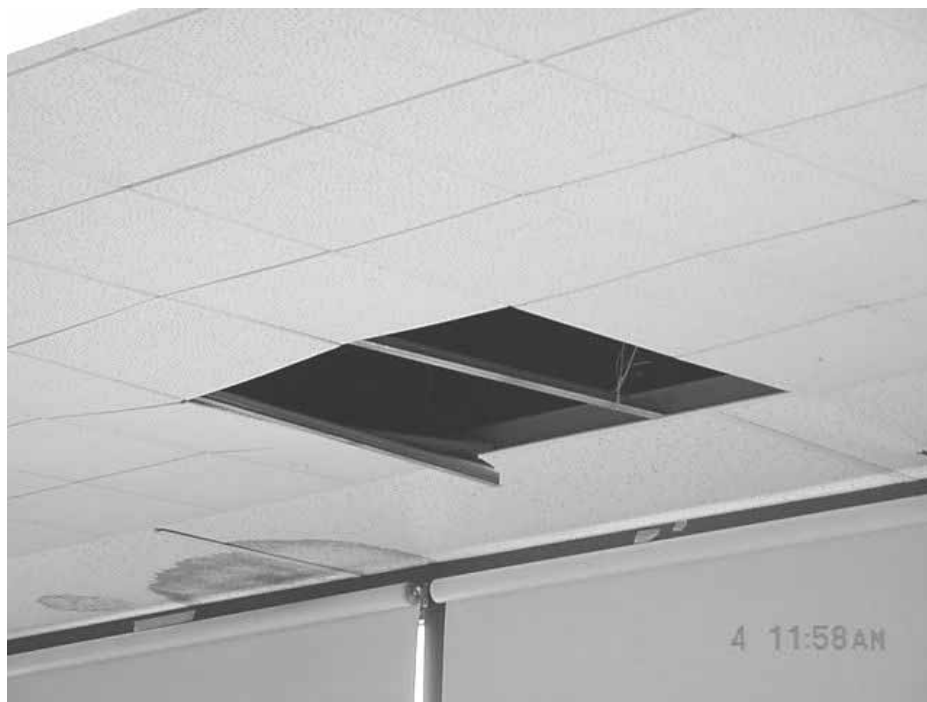
**Picture 11**

Several other conditions that can affect indoor air quality were noted during the assessment. Several rooms had missing and/or dislodged ceiling tiles (Picture 11). Missing and/or dislodged ceiling tiles can provide a pathway for the movement of drafts, dusts and particulate matter between rooms and floors. Accumulated chalk dust was noted in some

**Missing Ceiling Tiles**

13. Clean chalkboards and dry erase board trays regularly to avoid the build-up of particulates.
14. Replace missing/dislodged ceiling tiles.
15. Consider providing local exhaust ventilation for photocopiers in the copy room.

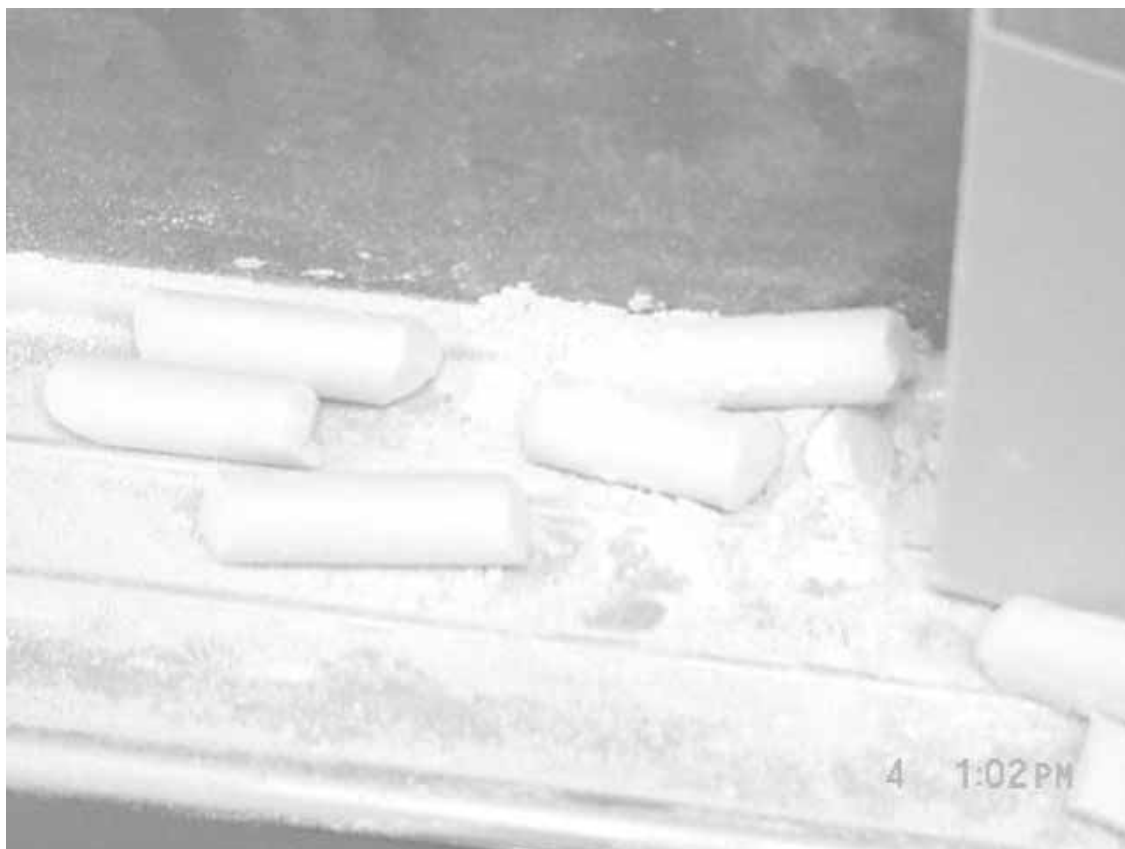
**Picture 12**

classrooms (Picture 12). Chalk dust is a fine particulate that can easily become aerosolized, irritating eyes and the respiratory system.

**Accumulated Chalk Dust in Classroom**
